Ōhau kia mau! Hold fast to the Ōhau River

The Ōhau River Loop

- Our restoration story -

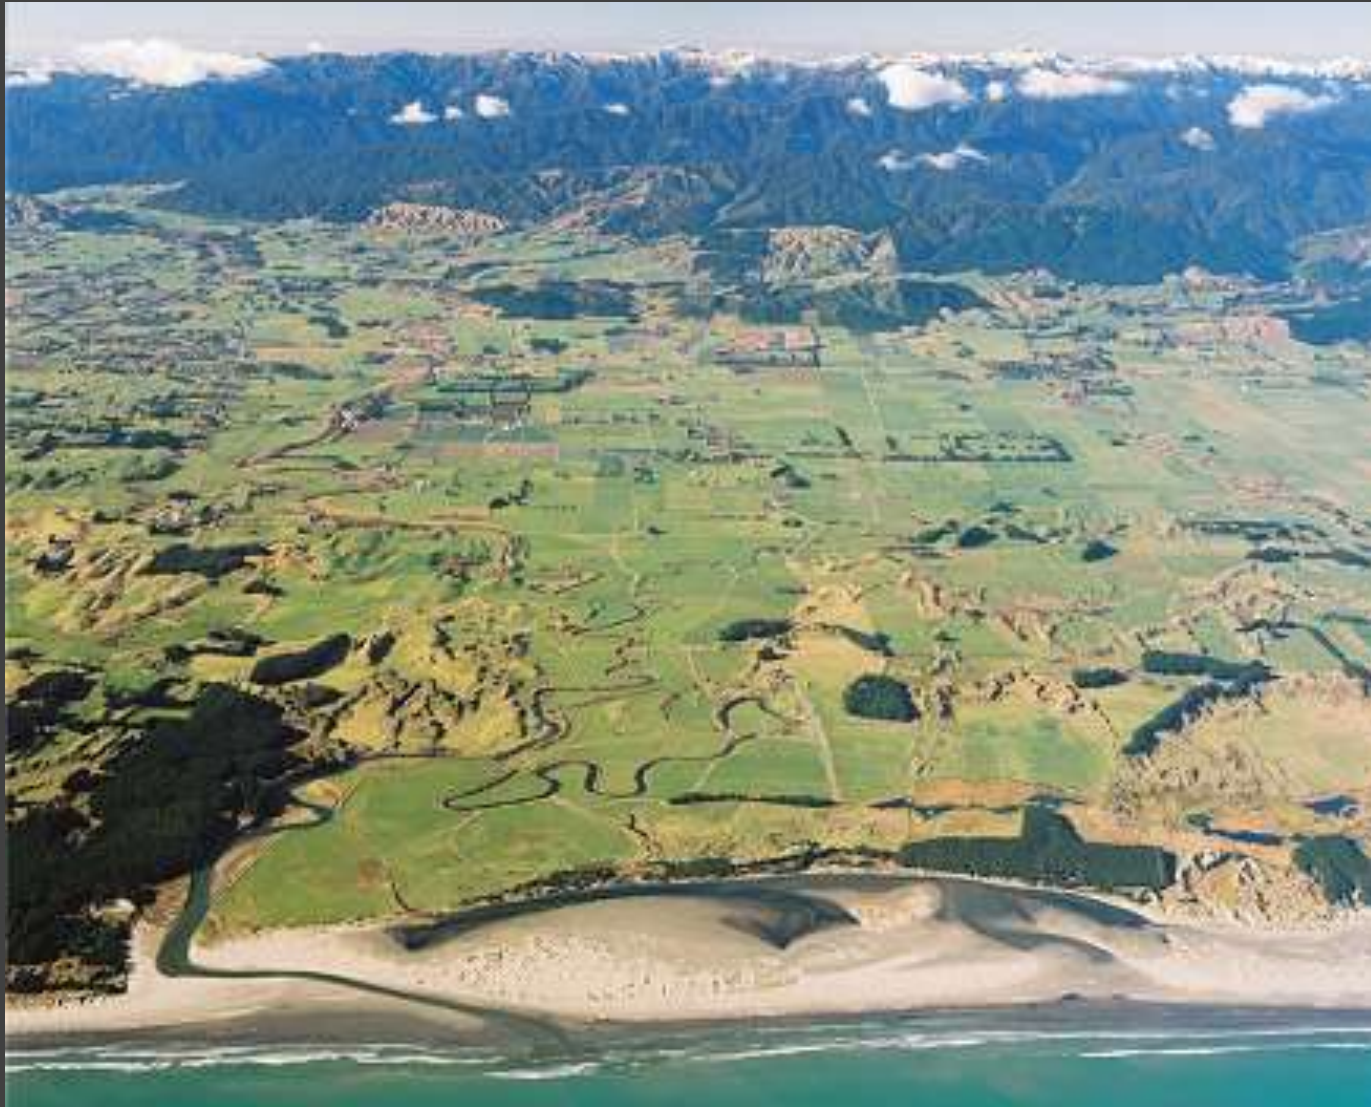
Ōhau River meander, c 1946.

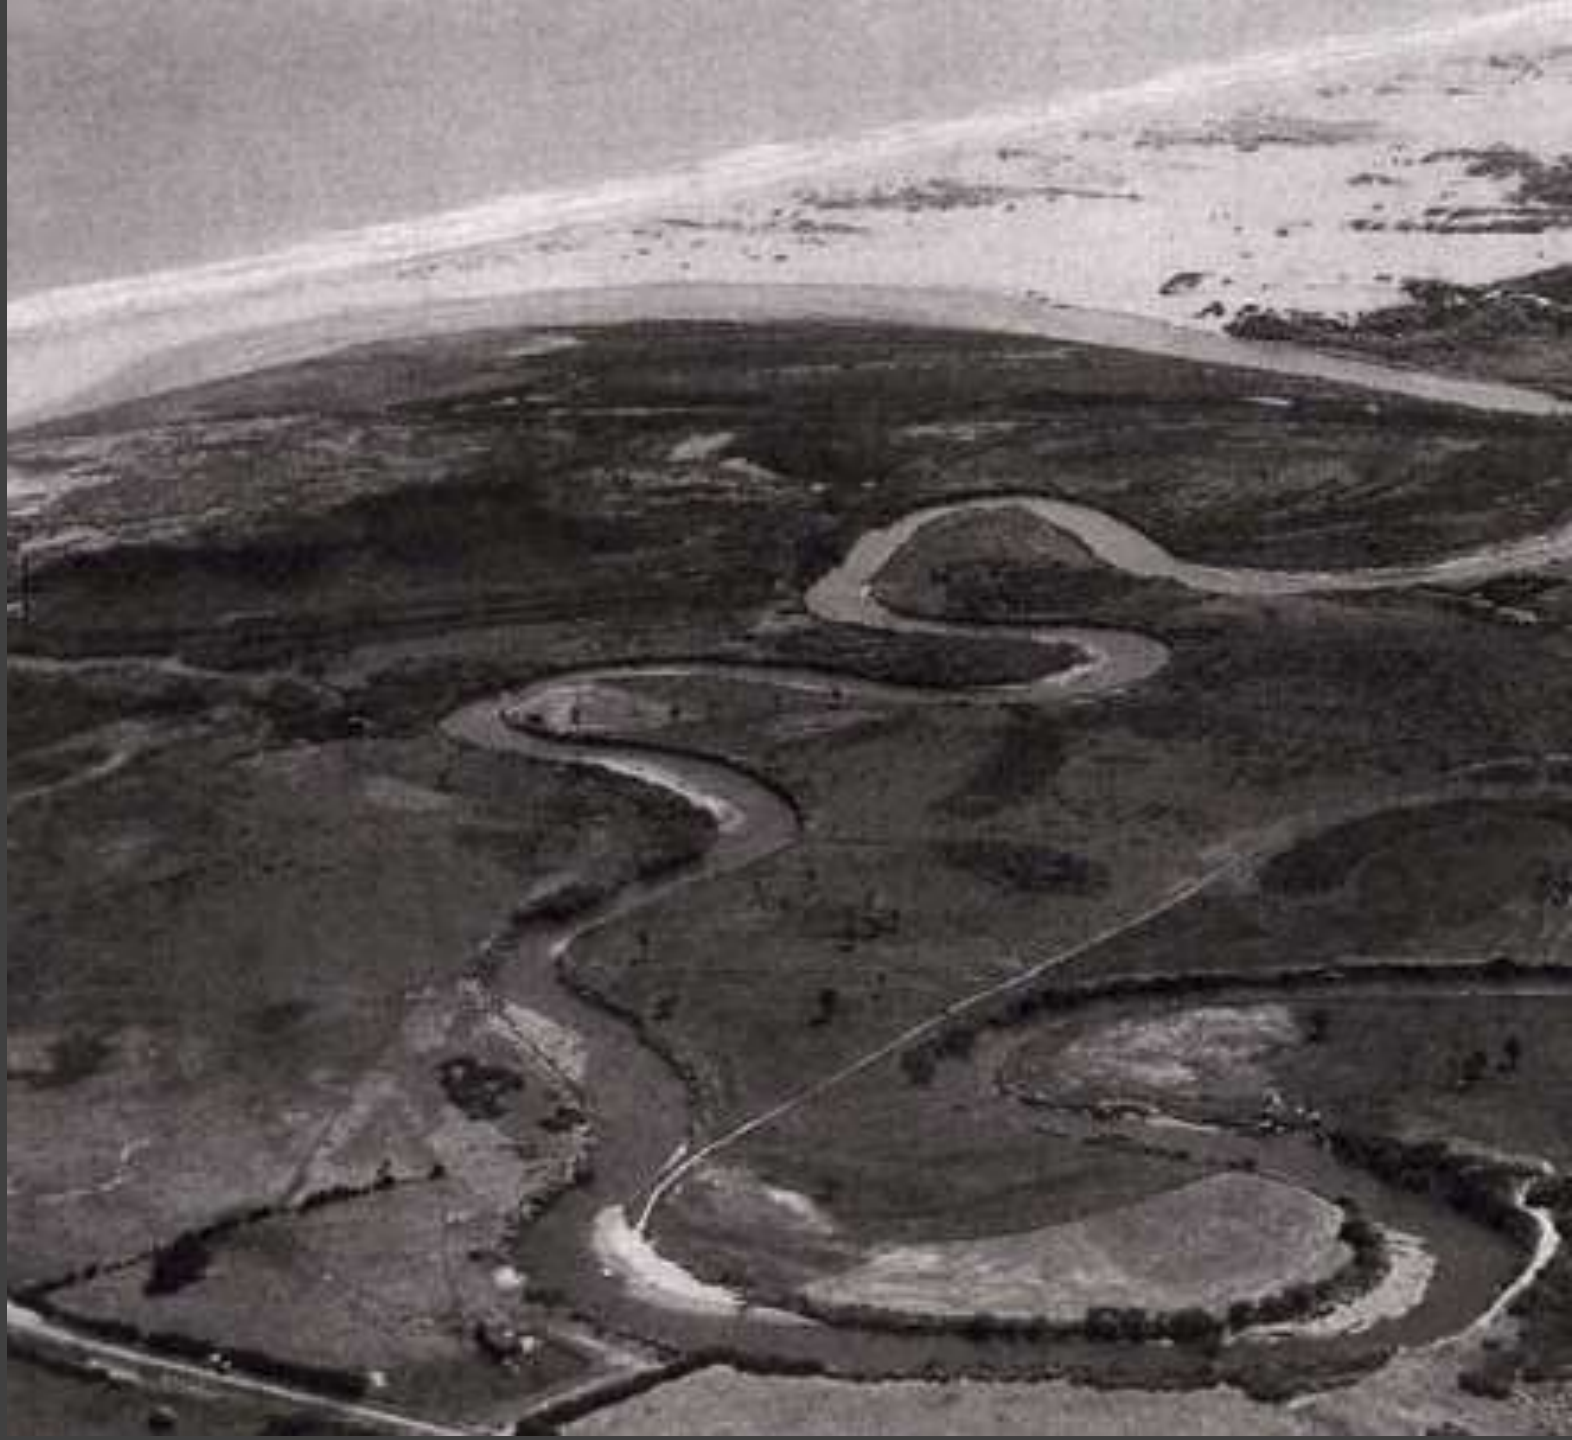
| The Ōhau River 'Loop'

1972 flood
protection
works to cut 3.5
km off the
'Loop'

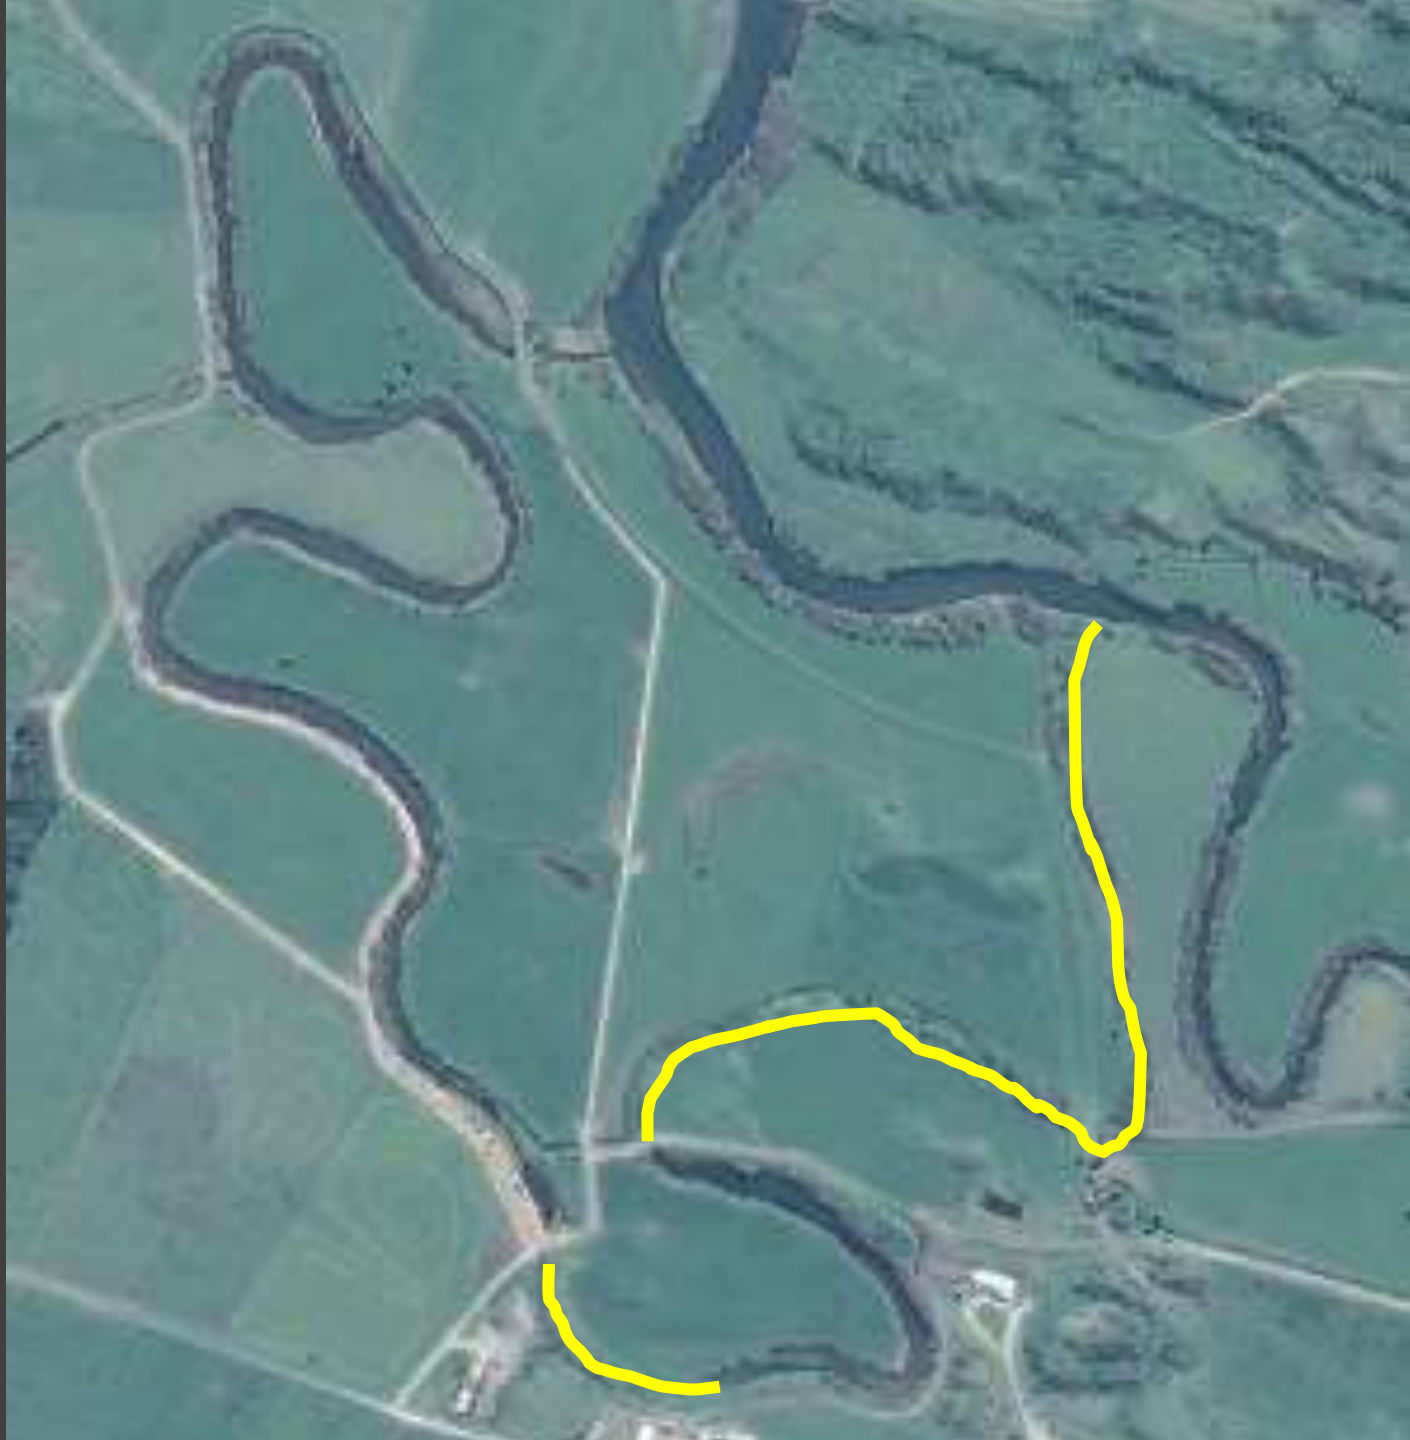
| Sediment depth

Ca. 104,000 m³ of fine
sediment
50m cube...

High in *E. coli* bacteria
stored in the sediment

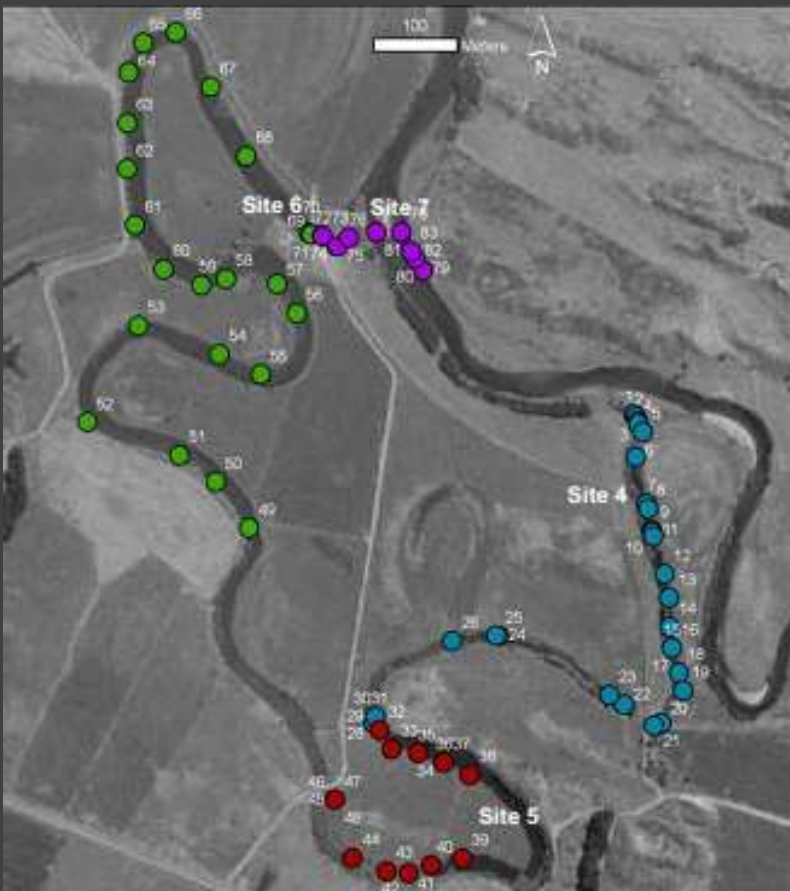
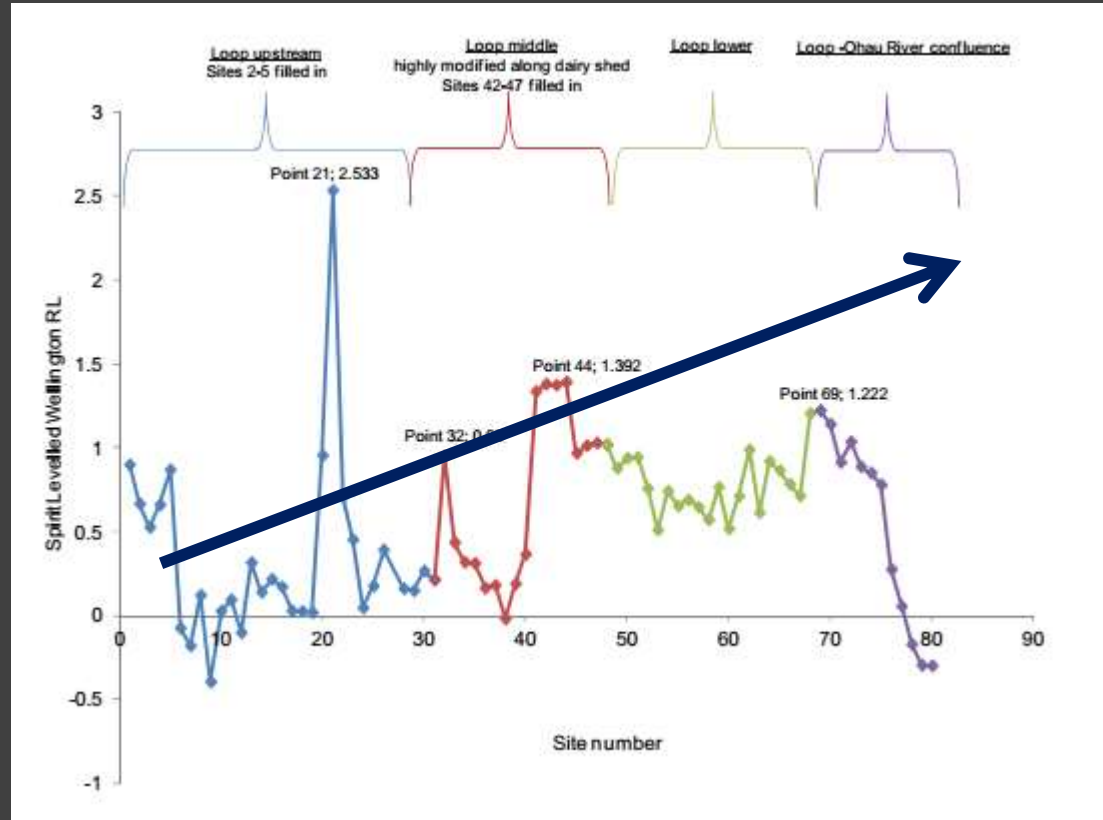
“Does this mean fish have to swim upstream to get downstream??”

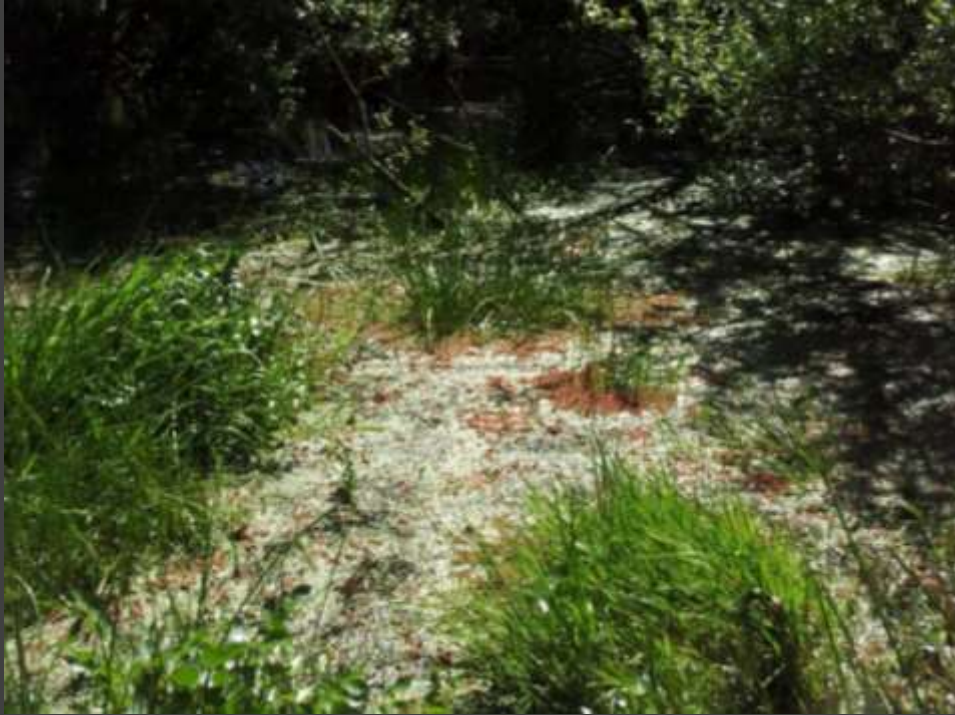
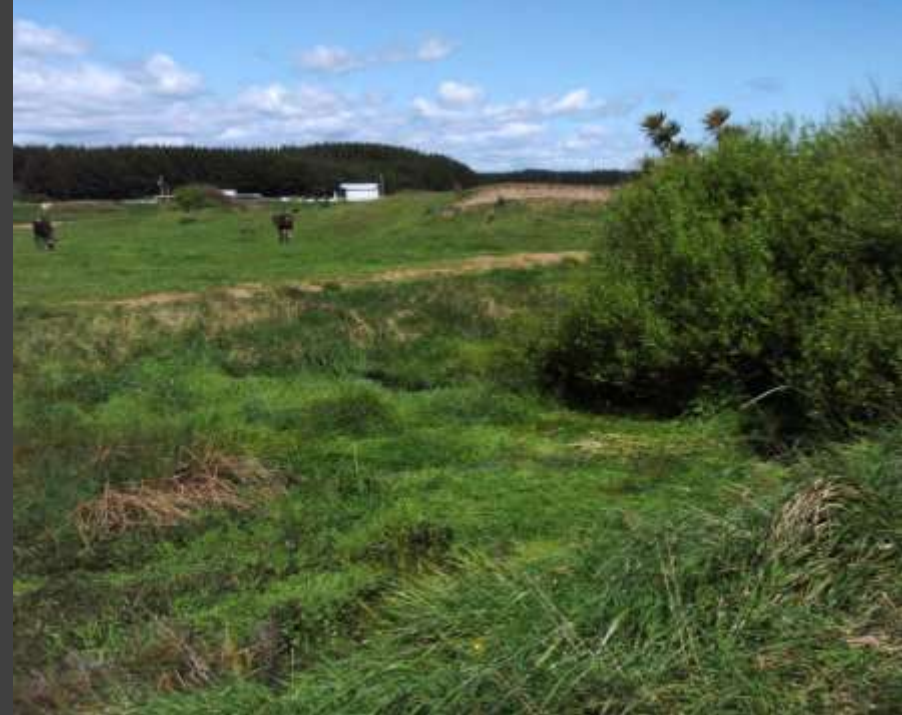
| Surface water flow

Images taken in 2012

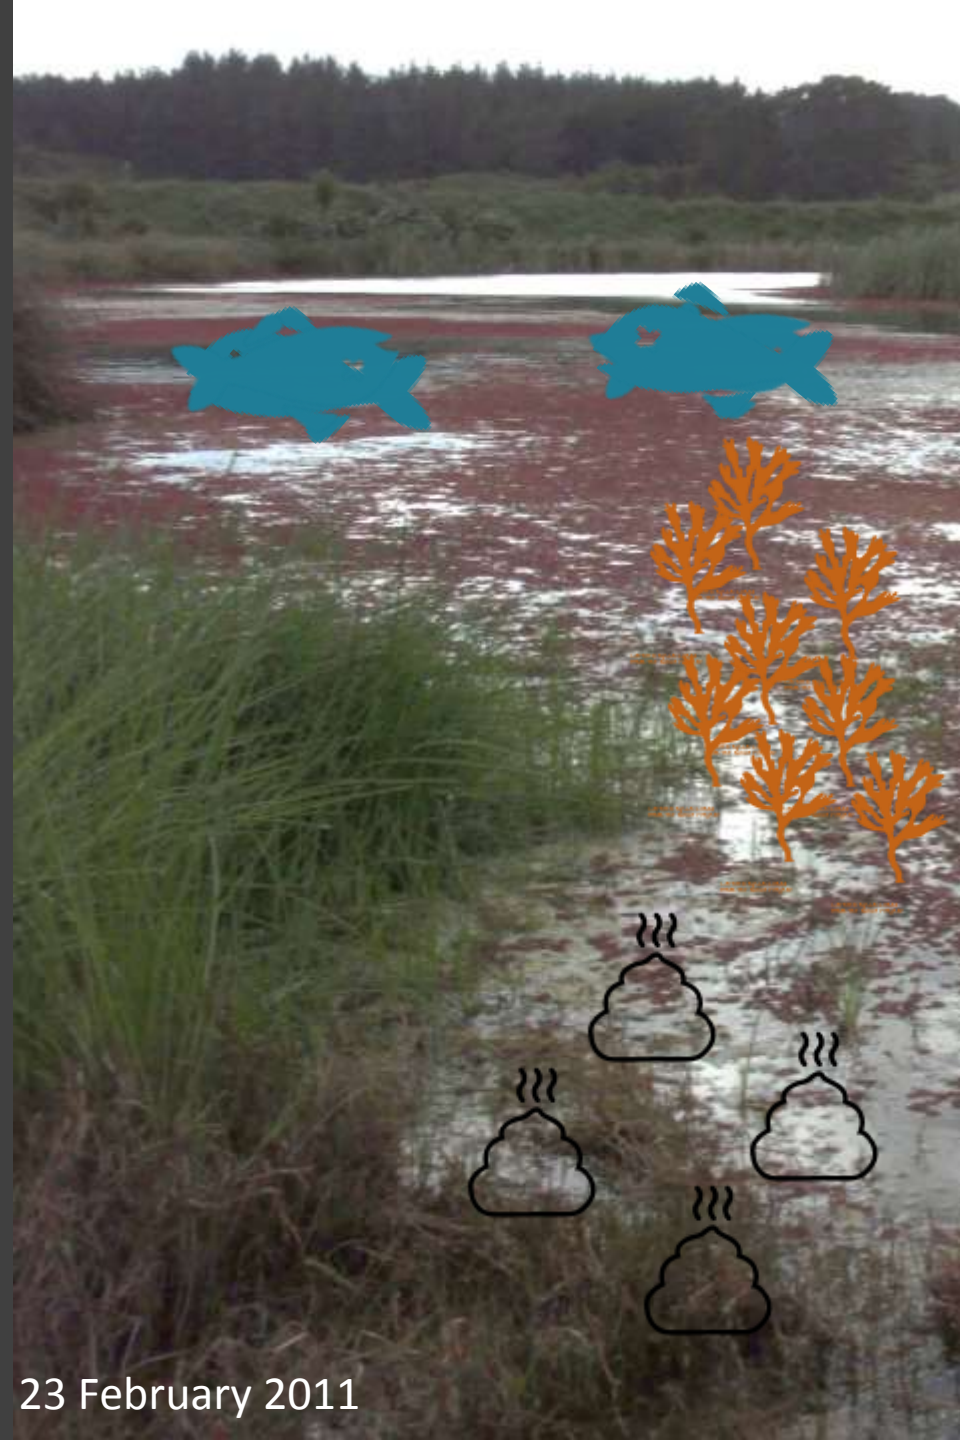
| Water quality

- Low dissolved oxygen levels
- High nutrients (nitrogen & phosphorus)
- High faecal coliform (*E. coli*) concentrations

23 February 2011

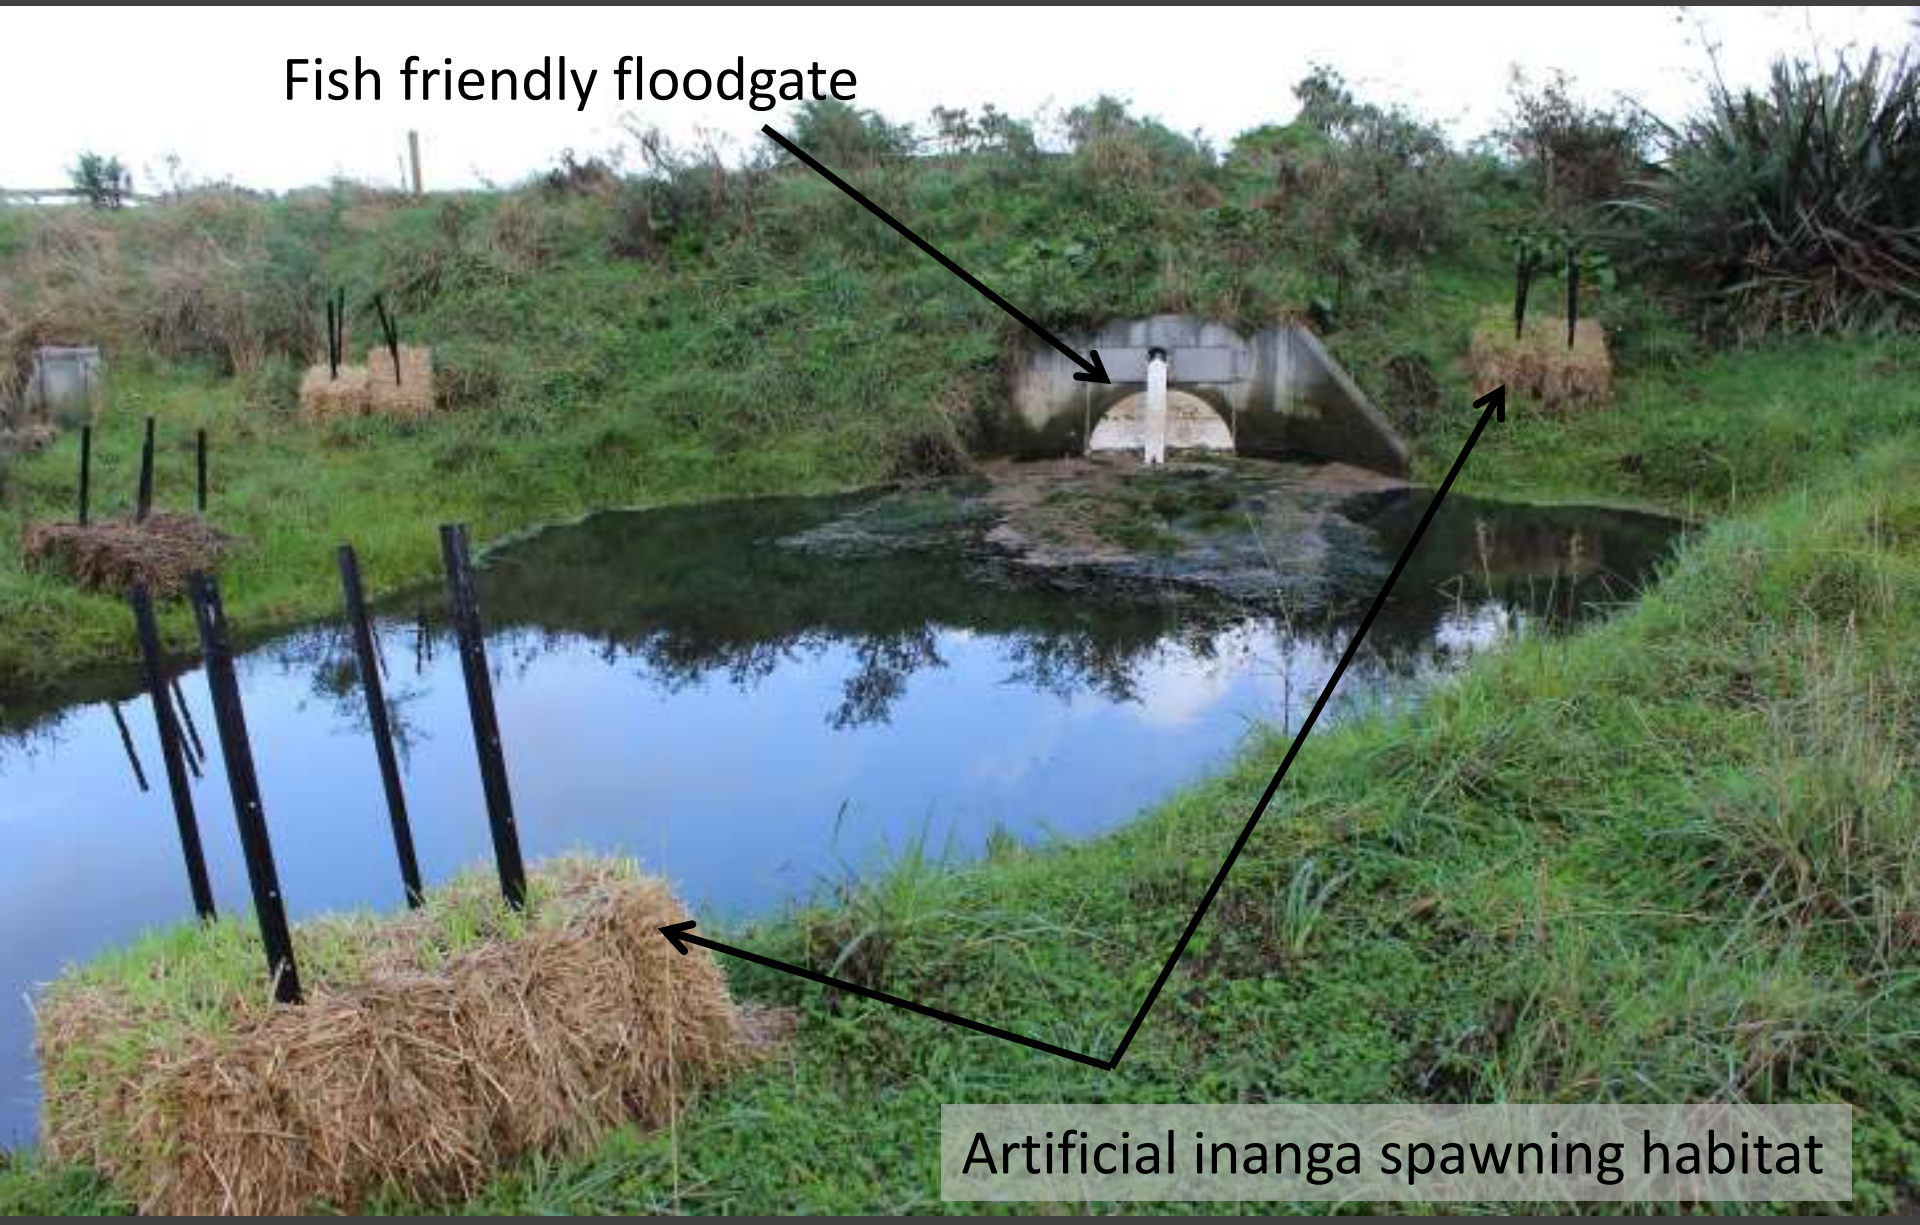
Fish friendly floodgate

Artificial inanga spawning habitat
